Manhole Inspection Summary

Manhole # S09II2020MH

Insp Date: **7/11/06 11:22 AM**

Location Address: **6505 EDENVALE RD**

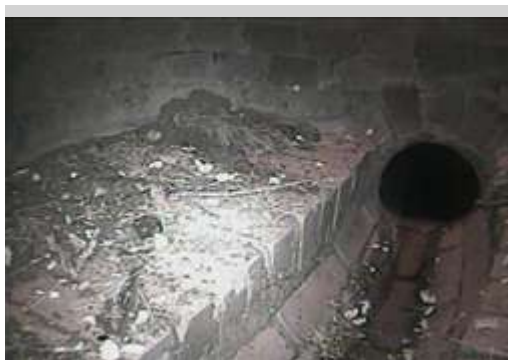
Bench debris

Bench ☒ Exists Material: **Brick** ☐ Parged ☒ **Debris** (not Condition related)

Bench debris.

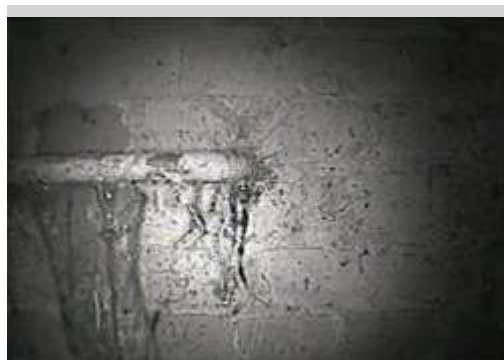
Evidence of surcharge

Surcharge ☒ **Evidence Of Surcharge** Depth: **2** (ft.) ☐ Active Surcharge Present

Evidence of surcharge.

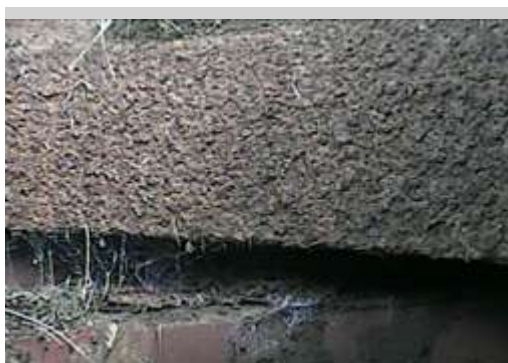
Defect

Frame Offset: **6.5** (in.) Condition: ☐ Sound ☐ Cracked ☒ **Leaks**

Infiltration: ☐ None ☒ **Joint** ☐ Cracks ☒ **Mortar** ☐ Roots ☐ Wall

Frame leaks. Adjustment infiltration.

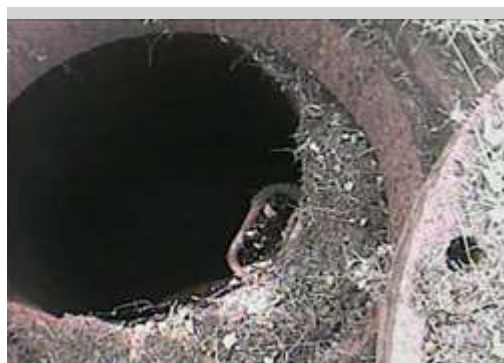
Defect

Frame leaks. Adjustment infiltration.
Adjustment root intrusion.

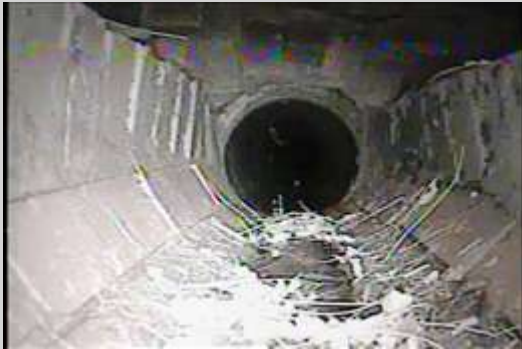
8 in. Circular Gravity Sewer Pipe Out @ 12 O'Clock

Comments **The I6 pipe picture shows Channel root intrusion.**

Condition: ☐ Sound ☐ Cracked ☒ **Root Intrusion** ☐ Deteriorated ☐ Leaks ☐ Debris
